Codding Farm Barn: Reuse and Rehabilitation Feasibility Report

Reuse and Rehabilitation
Feasibility Report

Community Partner:
North Attleborough Historical Commission

Fall 2013

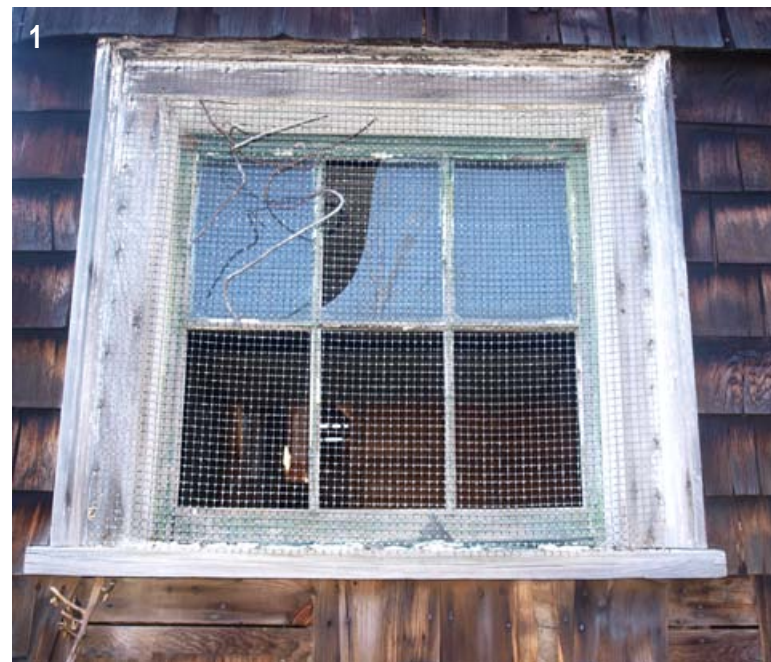
The windows are in varying levels of condition. Those located on the west elevation seem to be relatively protected, and therefore, the frames, sash, glass and glazing are still present. Windows on the east elevation have been completely removed leaving only the openings and frames. Some windows on the west elevation have a metal wire mesh on the exterior.

Structural System

1. West elevation window covered with metal wire mesh.
2. Many of the structural beams are rotting away and need to be replaced.
3. The collapsed north elevation is precariously balanced on a crooked wooden column.

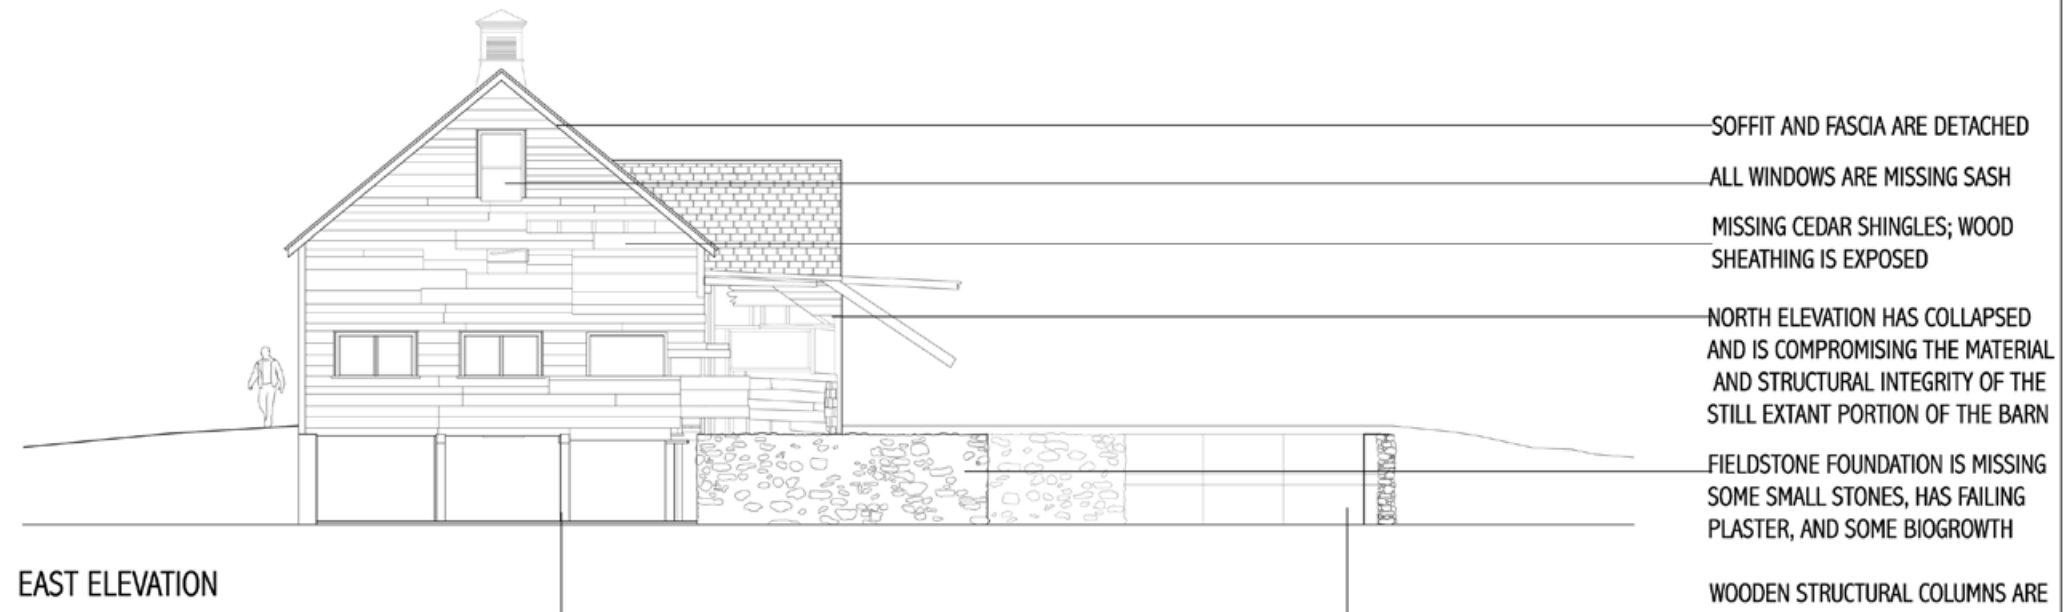
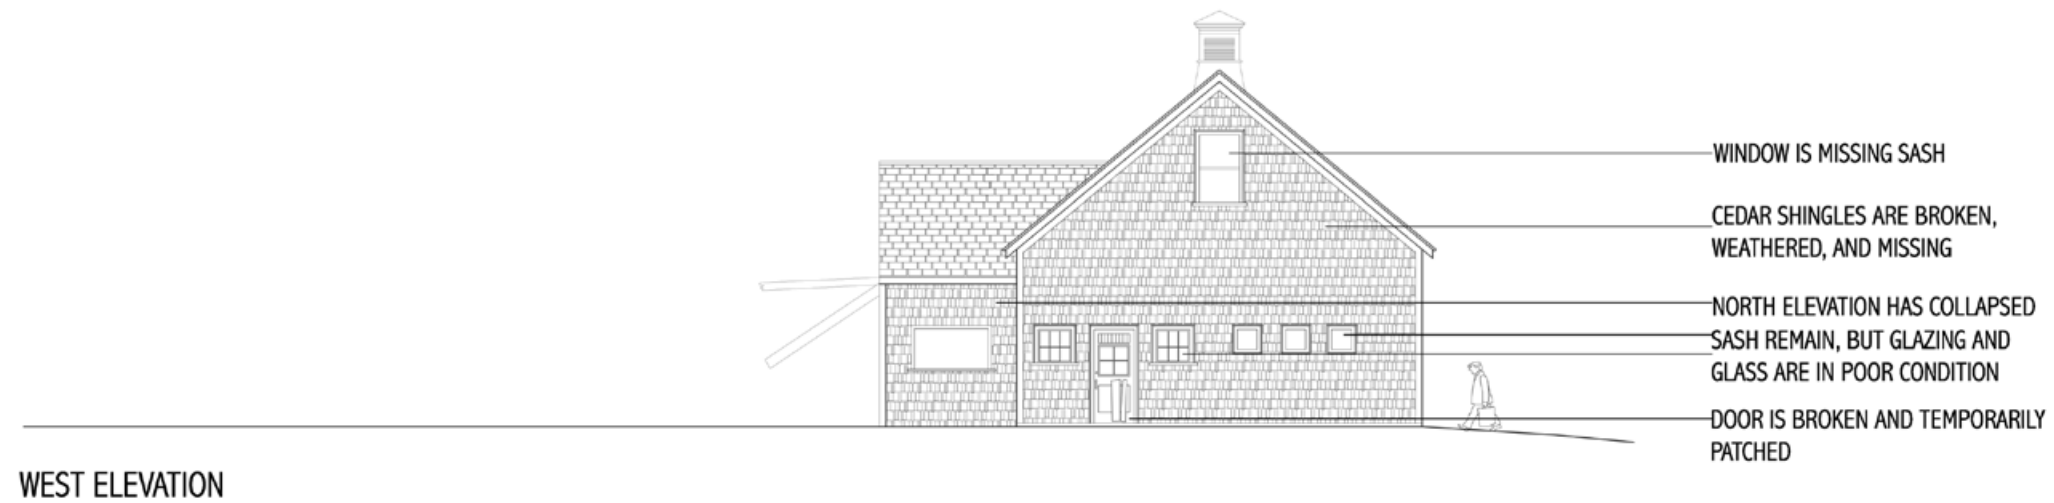
EAST + WEST ELEVATIONS

CUPOLA IS MISSING CEDAR SHINGLES ON ALL ELEVATIONS; WATERPROOFING MEMBRANE IS EXPOSED

ASPHALT SHINGLE ROOF IS IN GOOD CONDITION

CEDAR SHINGLES ARE BROKEN, WEATHERED, AND MISSING

TRANSOM WINDOW GLASS IS BROKEN

WINDOW IS MISSING SASH

DOORS ARE IN GOOD CONDITION AND RETAIN ALL ORIGINAL DETAILING

TRIM IS IN GOOD CONDITION; SOME AREAS OF ROT NEAR GROUND

FRAME AND SASH REMAIN; GLASS AND GLAZING ARE IN POOR CONDITION

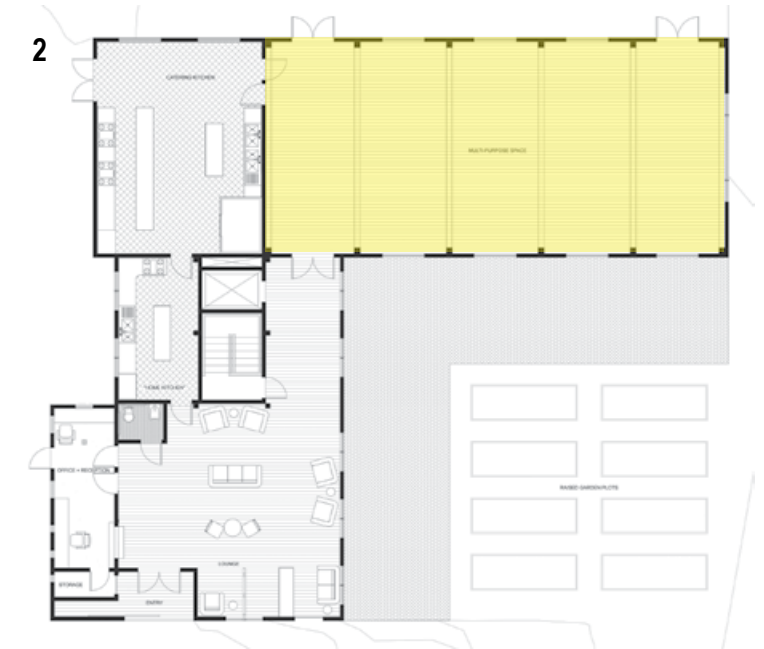
2. The yellow box in this proposed first floor plan shows the new addition to be built.
